NATIONAL TRANSPORTATION SAFETY BOARD

Highway Accident Report

Interstate 35W Collapse Over the Mississippi River, Minneapolis, Minnesota

NTSB/HAR-08/03

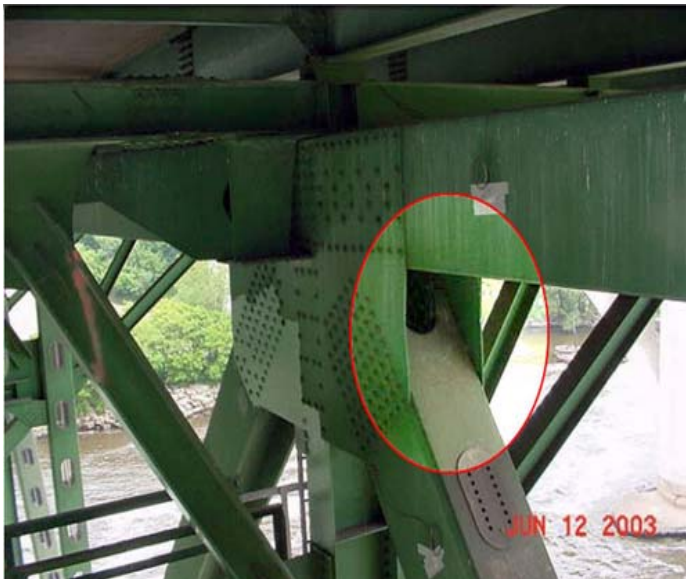
NTSB: The initiating event in the collapse of the I-35W Bridge was a lateral shifting instability of the upper end of the L9/U10W diagonal member and the subsequent failure of the U10 node gusset plates on the center portion of the deck truss.
